2.2 Existing Buildings

2.2.1 Warehouse 14

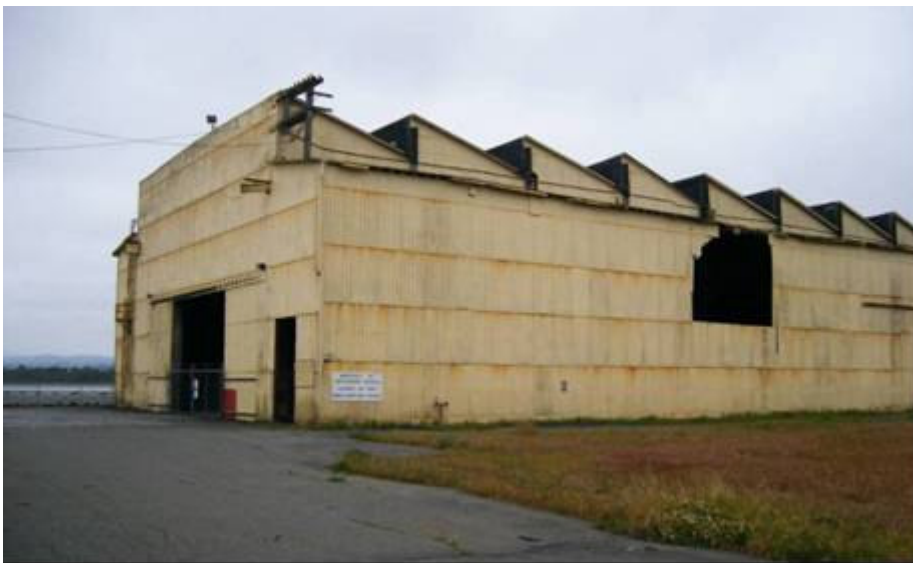
Figure 2-5: Warehouse 14 Exterior

Warehouse 14 has approximately 20 feet of vertical clearance at the north cargo entrance and about 36 feet of internal clearance to the bottom of the roof trusses. The exterior damage shown in Figure 2.5 is reported to be the result of a wind storm. The 2003 engineering report cited previously recommends that significant retrofitting and repair to the structure is necessary to bring it up to modern building code standards. In 2003, retrofit costs were estimated at \$1,061,190 (plus wind damage repair of \$35,000 to \$46,000). Replacement cost at that time was estimated to be about \$2,667,600. Currently the warehouse is not being used and plans for repair are pending a determination as to its future utility.

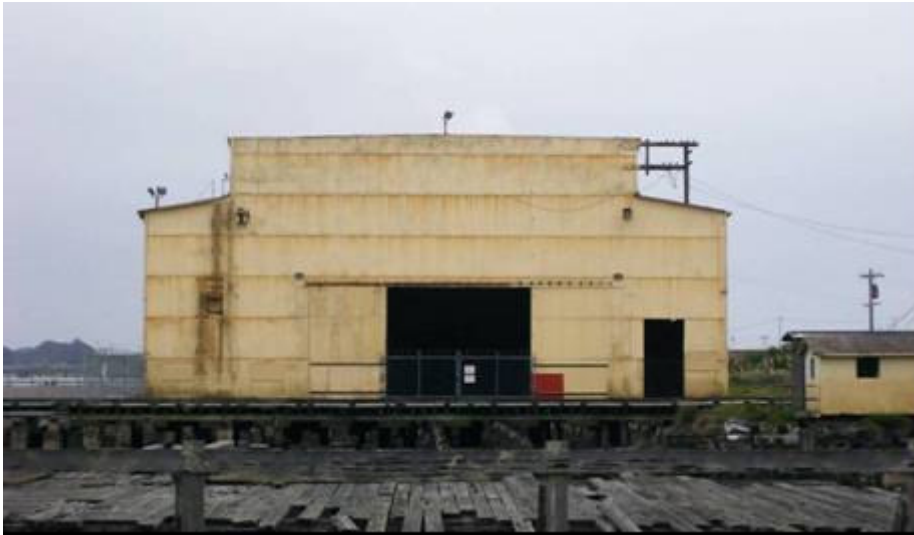
Figure 2-6: Warehouse 14 Existing Pile Supported Pier

The foreground of Figure 2.6 illustrates a gap in the deck of Berth 1 where another structure formerly stood. That structure has since been demolished and the berth was left in disrepair. In the background, the pile field supporting Warehouse 14 can be seen. Additionally the above ground electrical power connection and external flood lights can be seen on the north entry of the warehouse.

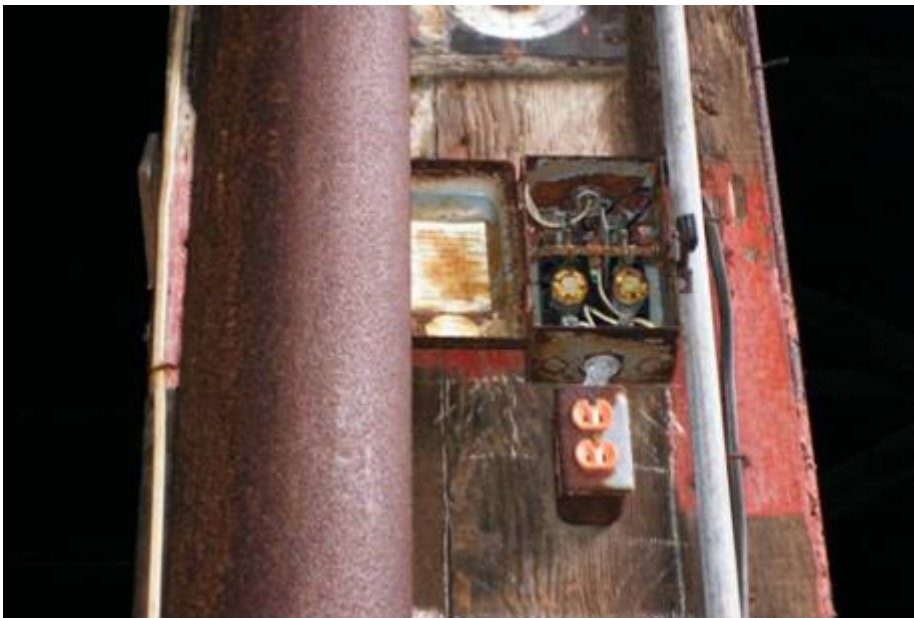
Figure 2-7: Warehouse 14 Wiring Sub-panel

Figure 2.7 is representative of the existing wiring within Warehouse 14. Figure 2.8 shows a fire main, presumed to feed a sprinkler system within the warehouse. Debris seen in the background is due to windstorm damage to the buildings sheathing.

The electric systems are working but are disconnected due to stability concerns of the structure. Fire water systems in the warehouse are in working condition but are shut down due to leaks in the system.

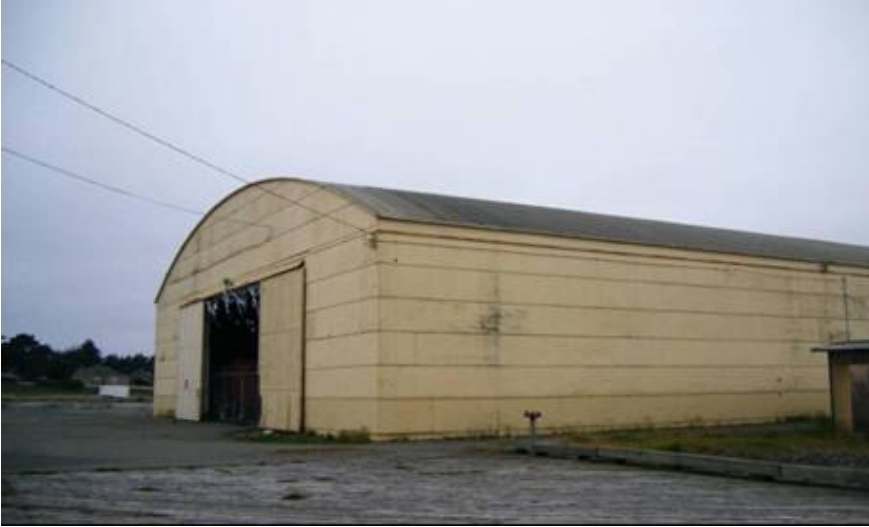
Figure 2-9: Warehouse 3 Exterior

Warehouse 3 is of a newer construction and appears to be in moderately good physical condition. Figure 2.9 shows the exterior condition of Warehouse 3.

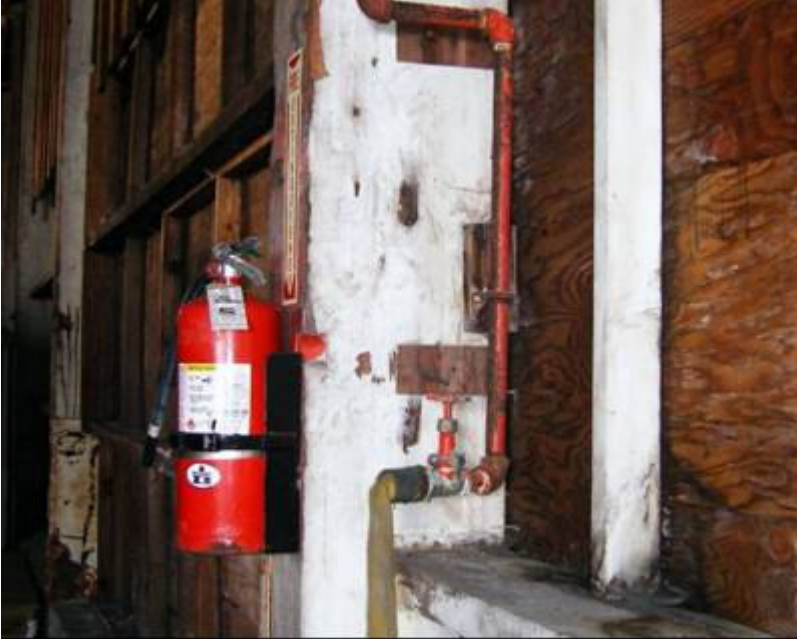
Figure 2-11: Warehouse 3 Timber Columns, Wall Structure and Fire Protection

Fire extinguishers attached to the interior of Warehouse 3 are assumed to be new upgrades to the warehouse. The hose attached to the fire main inside the warehouse also appears to be well maintained. However, the sprinkler system has been disconnected due to leaks in the fire main.

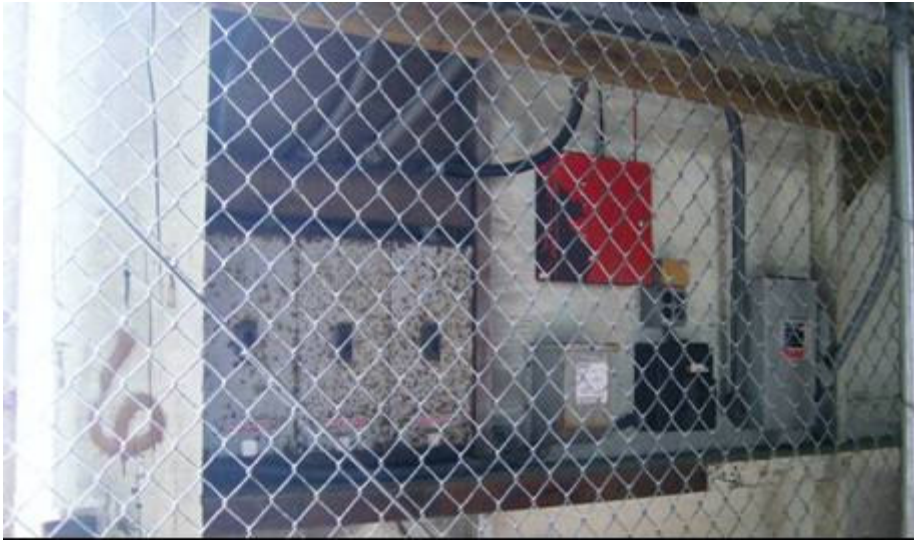
Figure 2-13: Electrical Junction Box

The Junction box shown in Figure 2.13 appears to be original to the structure. The electrical system is said to work but is currently disconnected.⁸ An engineering evaluation of all utilities and fire protection systems will be necessary to return Warehouse 3 to any significant commercial service. In addition, the operability of doors, ventilators and lavatories will have to be confirmed. The cost of these repairs should not preclude future commercial use of this structure.

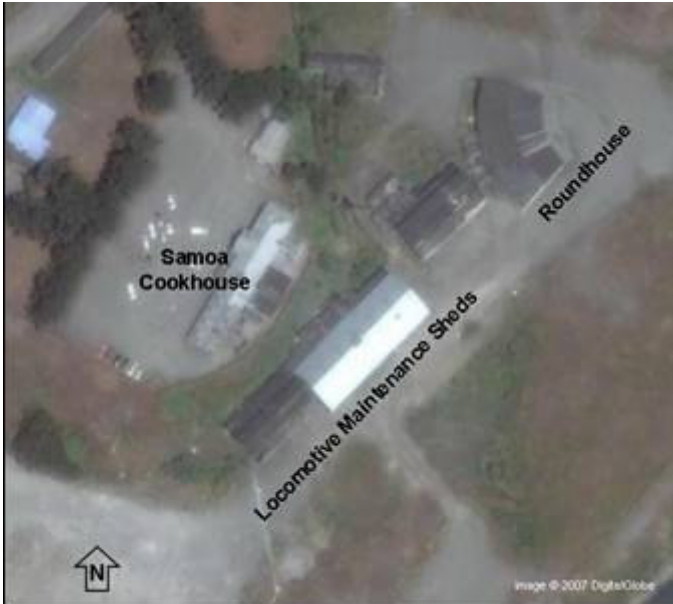
Figure 2-14: Maintenance Sheds and Roundhouse

The sheds are timber framed and constructed mostly of redwood. They are currently in varying condition and appear to all need some repair in order to be usable. The shed area is zoned Costal Dependent Industrial. However, in their present location and configuration, they are of limited value as components of a modern marine terminal.

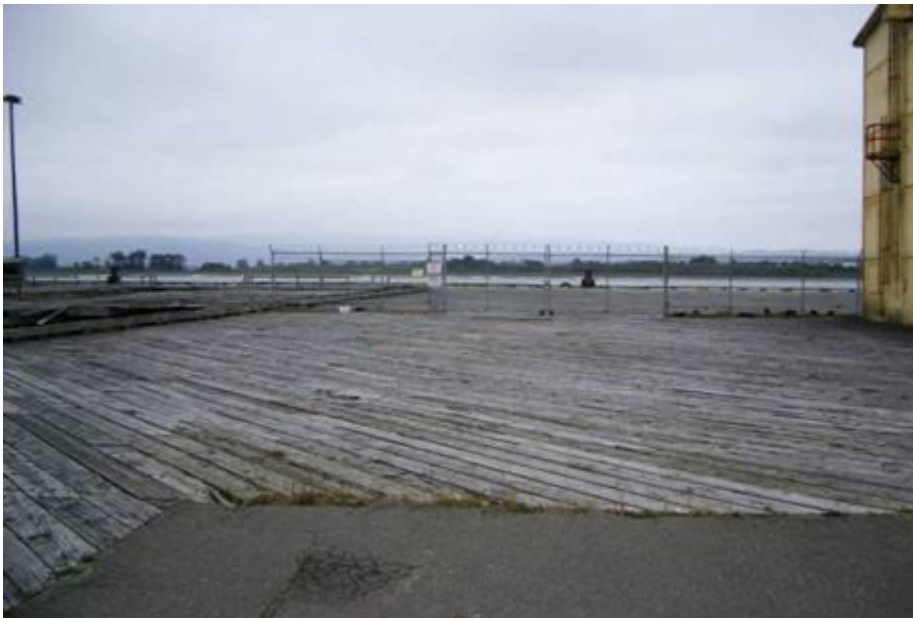
Figure 2-16: Berth 1 Timber Deck

The timber deck of Berth 1 varies in condition and load bearing capability. The deck shown in the foreground of Figure 2.16 is likely to have a capacity approaching that found inside Warehouse 14. However, the deck in the background extending towards the water is of unknown capacity and has been fenced against unauthorized vehicle access. Some portions of the deck are partially dismantled or have deteriorated to where damage is visible from the top.

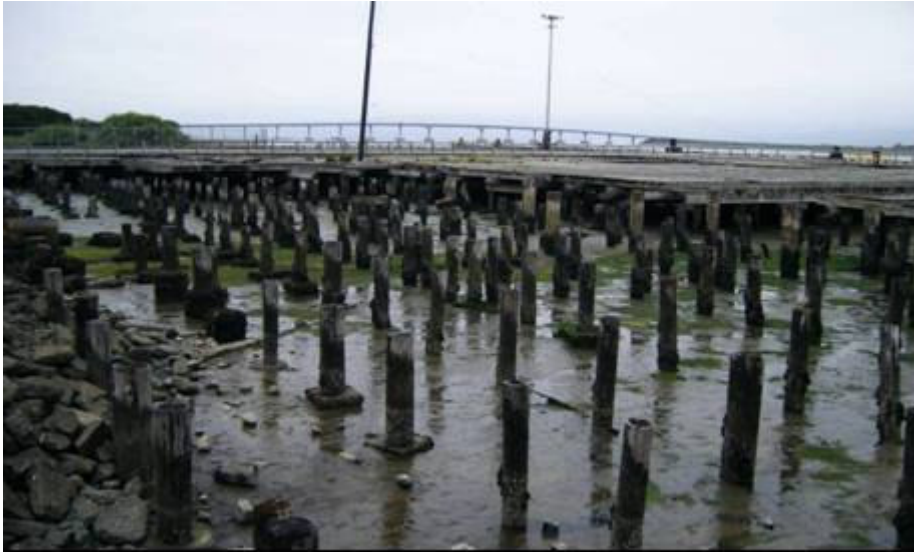
Figure 2-17: Berth 1 Interior Piling Field

Figure 2.17 illustrates an open piling field within the footprint of Berth 1 that is the site of a former, pile supported structure, since demolished. The middle of the background shows the pile cap, joist and plank construction of the remaining Berth 1 deck. The bearing capacity of this deck is unknown. Figure 2.18 shows the piling field and rip-rap shoreline at Berth 1. Warehouse 3 is on the shore, in the background.

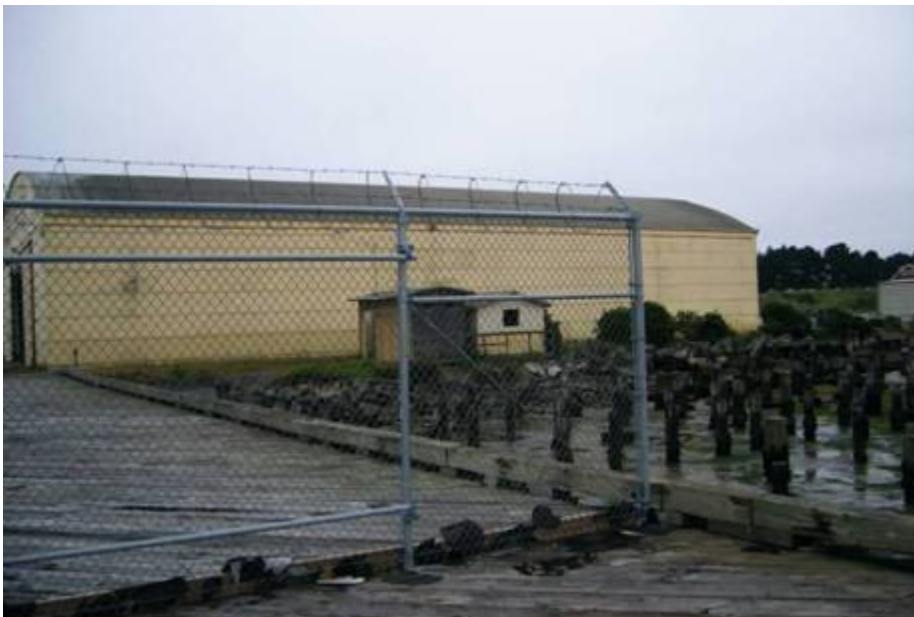
Figure 2-18: Berth 1 Access Control Fencing

The access control fencing at Berth 1 (also shown in Figures 2.16 to 2.18) is not up to the standards set by the Maritime Transportation Security Act (MTSA) of 2002. The act requires that a terminal be 100% fenced, securing all terminal assets, and cargo from possible terrorist acts. This would fall under requirements of an approved security plan for the terminal mandated by the Department of Homeland Security (DHS).¹² Other requirements of an approved terminal security plan include:

The District has an approved security plan that allows restricted use of the facility by cruise ships. No passengers are allowed to get off and on the ship at Berth 1. Instead they must be ferried by water between the cruise vessel and the City of Eureka's F-Street dock across the bay. Future development and commercial use of the Redwood Marine Terminal would require development of a comprehensive terminal security plan.

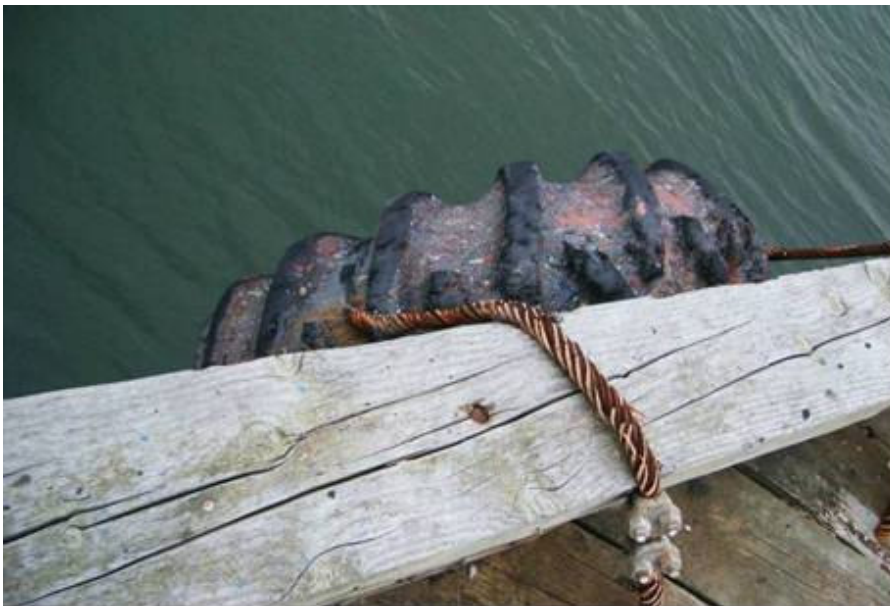
Figure 2-19: Berth 1 Existing Fender System

Figure 2.19 illustrates the existing fendering at Berth 1. It is likely that the berth was originally designed with fender piles that have since been removed or broken off. The current fender system is constructed of cable suspended tires. This type of fender is adequate for casual use by small vessels but is not capable of providing a secure mooring system for modern commercial ships.

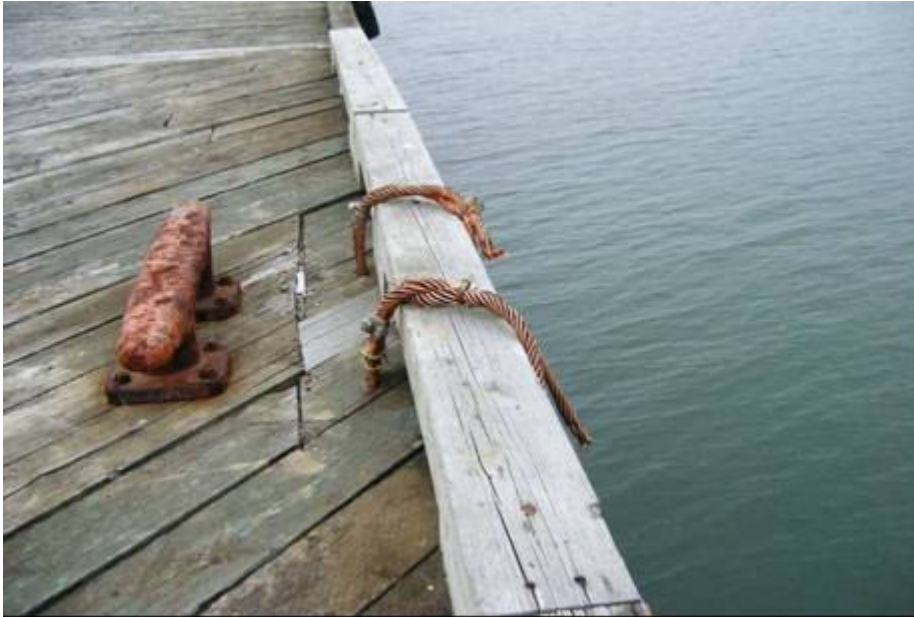
Figure 2-20: Berth 1 Existing Mooring Point

The mooring cleats as shown in Figure 2.20 are also adequate for smaller vessels and casual use. Their pull-out capacity is unknown and would be dependent on the condition of their attachment bolts. It is likely that the horizontal load capacity of the wharf exceeds the capacity of the mooring cleats.

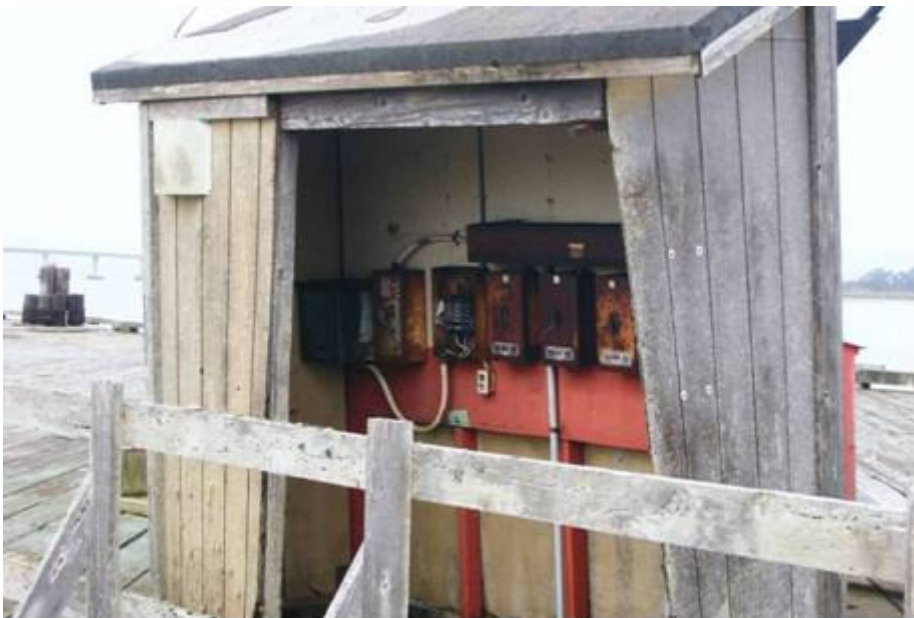
Figure 2-21: Berth 1 On-Dock Electric Switch Box

The electrical systems on Berth 1 are said to be working but disconnected.¹³ This report recommends that the electrical systems be rebuilt if the existing Berth 1 structure were returned to commercial use.

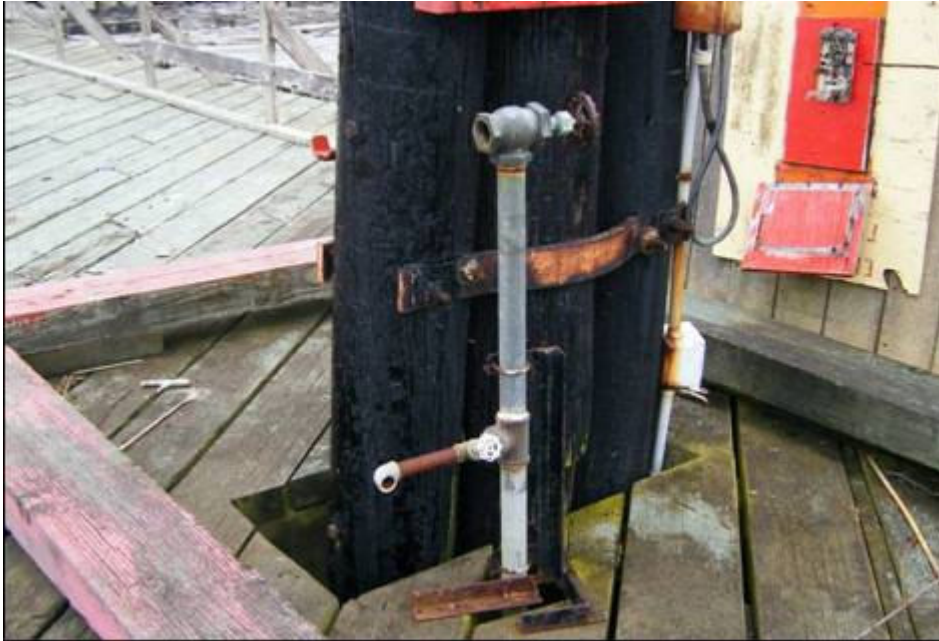
Figure 2-22: Berth 1 On-Dock Fire Control Pressurized Stand Pipe

The on-dock fire control system is absent of routine maintenance. The system works but is disconnected due to leaks in the fire main. The system may require dismantling and rebuilding in the future. It is possible that the fire control systems do meet current fire code requirements. TranSystems recommends that the fire control systems be improved or rebuilt if Berth 1 were to be returned to commercial use.

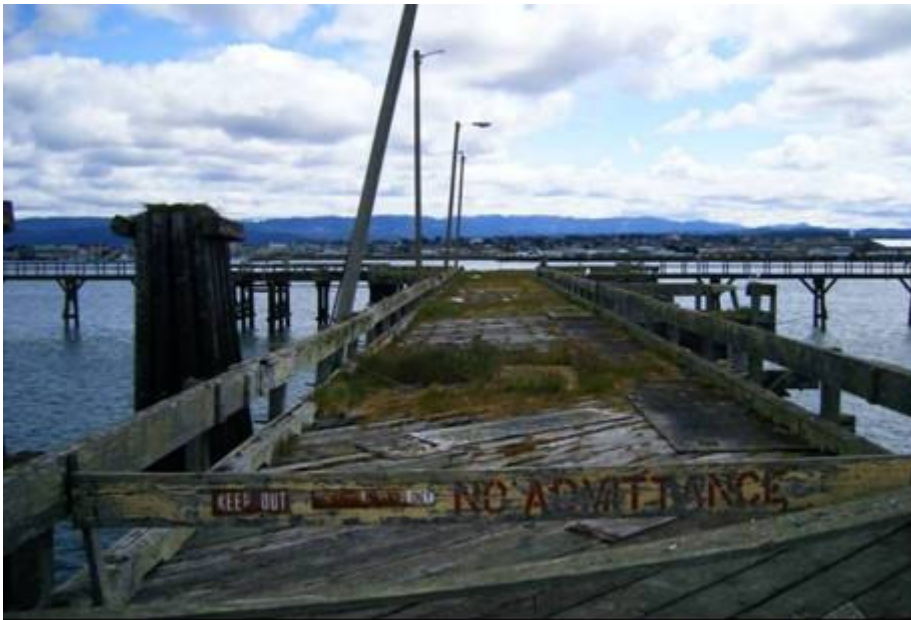
Figure 2-23: Berth 2 Ship Berth Access Pier

The ship berth consists of a 60 foot X 70 foot loading platform, four fendered breasting dolphins, and two outer mooring dolphins. The entire ship berth extends approximately 1,160 feet along from mooring dolphin to mooring dolphin with an available berth length of approximately 900 to 1,000 feet, depending on vessel configuration. NOAA Chart Number 18622 shows a depth of 32 feet at the face of the ship berth¹⁵. This berth was originally used to unload liquid chlorine from ocean going vessels, via pipeline, to the adjacent pulp mill. The breasting and mooring dolphins are of concrete pile structure and appear to be in usable condition. However, the ship berth access pier (easternmost 178 foot section) and connecting catwalks have been declared unsafe for use as illustrated in Figure 2.23.

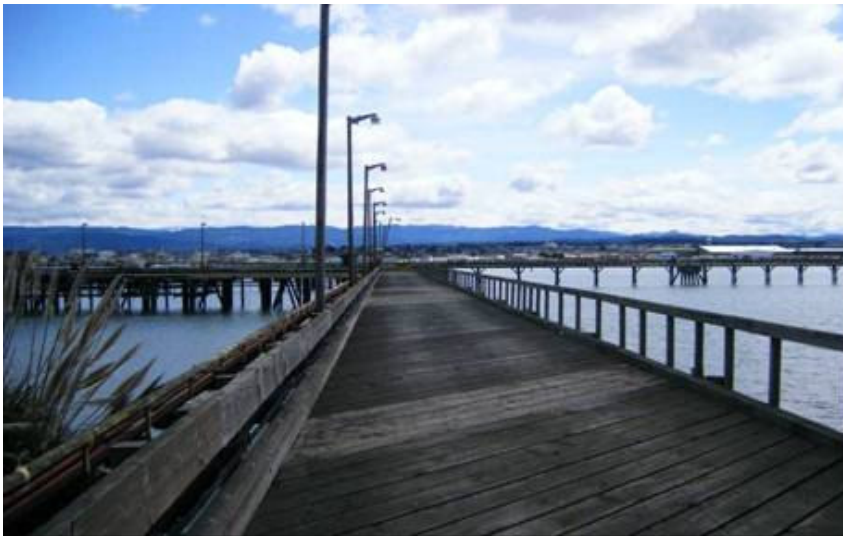
Figure 2-24: Berth 2 – Barge Berth Access Pier

The barge berth and the shed as shown in Figure 2.24 includes various piping and control systems that appear to be designed for the unloading of chemicals and other resources necessary for the processing of wood pulp. The berth has water and electric service and they appear to be in working condition. The decking of the Berth 2 access pier, the barge berth pier and the associated catwalks are constructed of pile supported timber planks. The load bearing characteristics of the pier are unknown and would require further evaluation. The barge berth and the associated access pier appear to be in adequate condition for commercial use. However, a structural evaluation will be necessary before equipment or vehicles can use the facility.

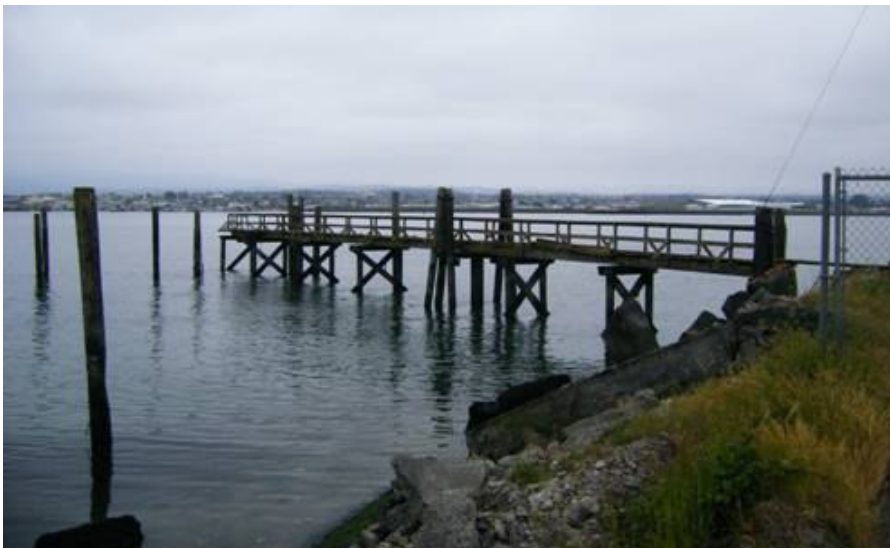
Figure 2-27: Unnamed Harbor District Dock

The dock was once a part of LP and Simpson Samoa operations but is no longer in use. It is unfit for commercial or recreational use. The removal of the dock could be used as mitigation for future terminal development.

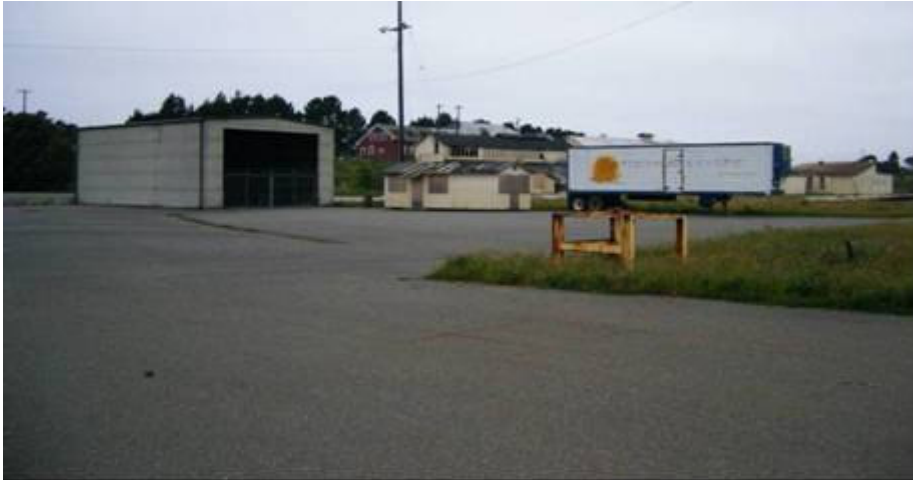
Figure 2-28: Open Storage Pavement North of Warehouse 3

The Redwood Marine Terminal open storage includes about 17 acres of mixed paved and unpaved areas. The surface of the unpaved areas is currently overgrown with low vegetation and the original surface conditions, (gravel, earth, etc.) have not been evaluated. The paved surfaces are relatively clear and appear to be in good condition. This pavement is fully contiguous with paved portions of the adjacent Samoa Property and it can be assumed that the existing drainage and underground utilities are common to both. Portions of the pavement closest to the entry gate, Roundhouse, and Berth 1 appear to have the greatest structural integrity. Figure 2.28 illustrates portions of that pavement to the north of Berth 1 and Warehouse 3, facing the terminal entrance.

Some areas of the pavement show minor damage, but there is little evidence of excessive pavement failure or overloading. This paved area was originally used for storage of sawn timber and heavy truck circulation. Although the design pavement load is unknown, it may be suitable for commercial port use without significant modifications.

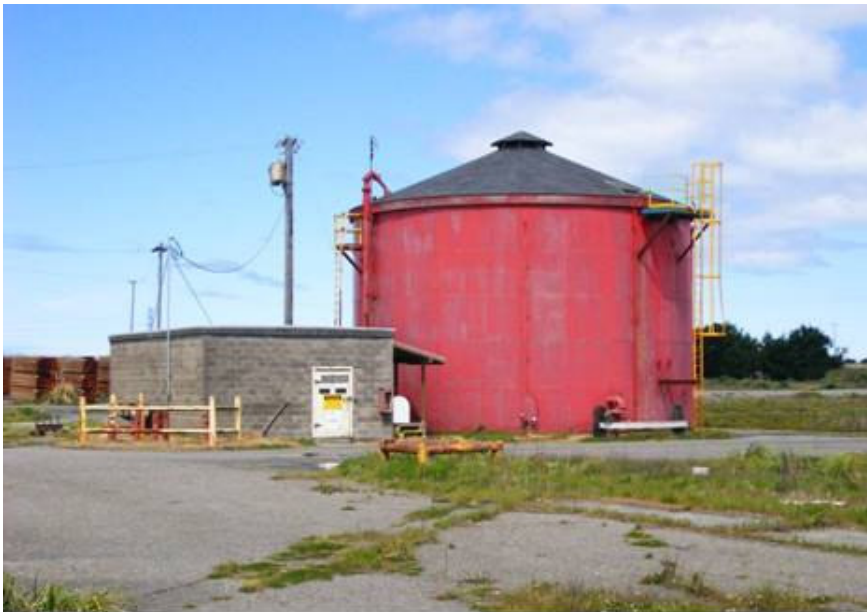
Figure 2-30: Fire Main Pump Station

The Fire Protection Pump Station (see Figure 2.30) is located on District property and is the primary fire protection for the Redwood Marine Terminal, Simpson Samoa, and the town of Samoa. The Pump Station falls under a shared services agreement between the District and Samoa Pacific Group, which covers future use of utilities. The Samoa Master Plan observed that some portions of the fire control system are sub-standard while other parts are above standard. It is intended that the pump station remain with future terminal re-development and that appropriate upgrades to the fire system be implemented to support modern terminal operations.
