2.2 Existing Buildings

2.2.1 Warehouse 14

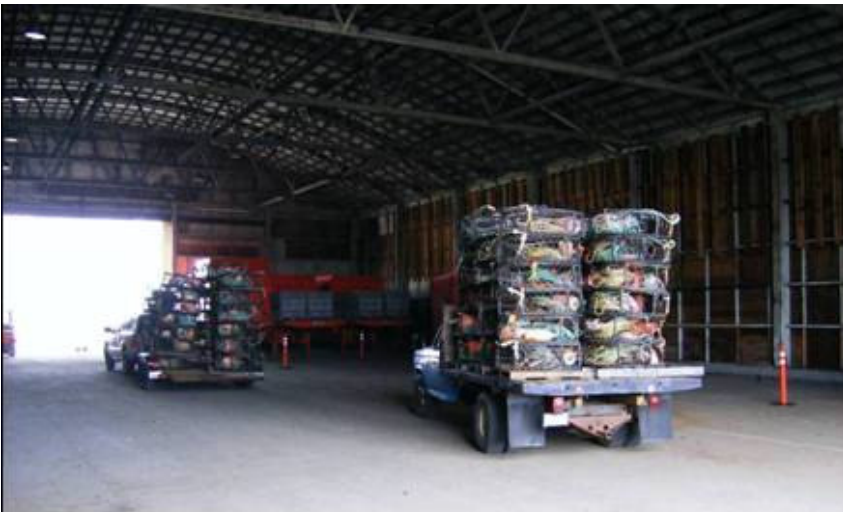
Figure 2-10: Warehouse 3 Interior

Warehouse 3 is approximately 16,000 square feet, built on the upland behind Berth 1. The structure is of timber construction with metal roof and roof trusses. This warehouse has a cement floor that appears to be a slab-on-grade. The metal roof in the warehouse appears to be in good condition with no visible sign of structural distress. The building has received recent maintenance and presently has no damage or leaks. The bay doors and internal vertical clearances are approximately 20 feet, large enough to allow for forklift and over-the-road truck operation. This warehouse is currently leased and used for the storage of commercial fishing gear and U.S. Coast Guard oil spill recovery equipment. Warehouse 3 is also designated as a Foreign Trade Zone⁷ but is not currently used in that capacity.

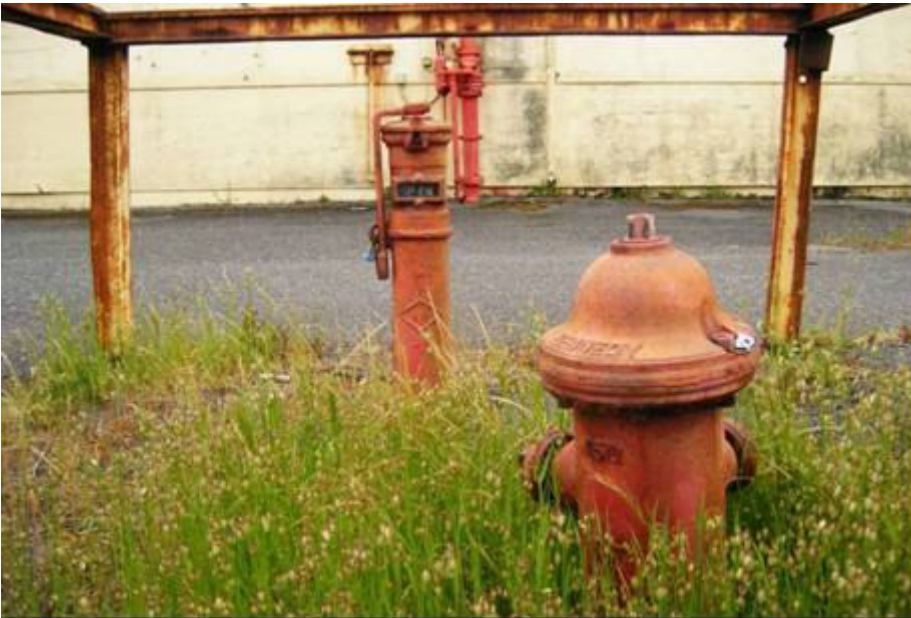
Figure 2-12: Warehouse 3 External Fire Protection and Fire Main Control

Fire extinguishers attached to the interior of Warehouse 3 are assumed to be new upgrades to the warehouse. The hose attached to the fire main inside the warehouse also appears to be well maintained. However, the sprinkler system has been disconnected due to leaks in the fire main.

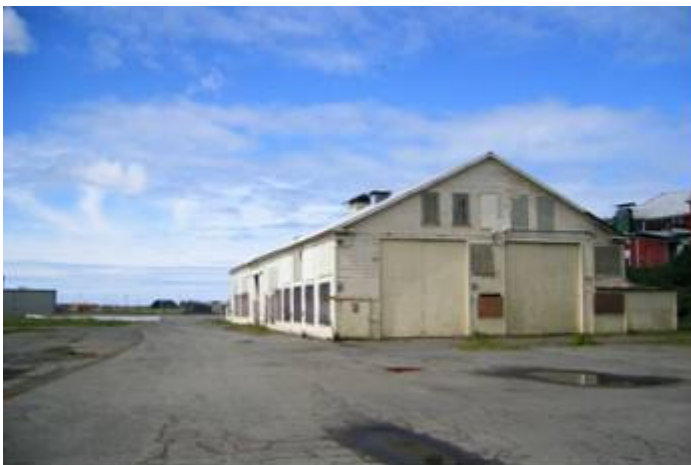
Figure 2-15: Locomotive Shed

The sheds are timber framed and constructed mostly of redwood. They are currently in varying condition and appear to all need some repair in order to be usable. The shed area is zoned Costal Dependent Industrial. However, in their present location and configuration, they are of limited value as components of a modern marine terminal.

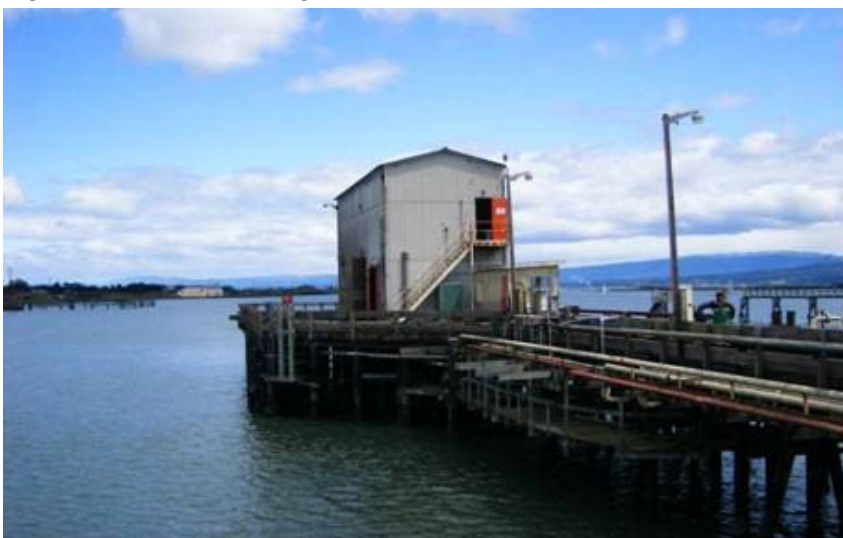
Figure 2-25: Berth 2 – Barge Berth Equipment Shed

The barge berth and the shed as shown in Figure 2.24 includes various piping and control systems that appear to be designed for the unloading of chemicals and other resources necessary for the processing of wood pulp. The berth has water and electric service and they appear to be in working condition. The decking of the Berth 2 access pier, the barge berth pier and the associated catwalks are constructed of pile supported timber planks. The load bearing characteristics of the pier are unknown and would require further evaluation. The barge berth and the associated access pier appear to be in adequate condition for commercial use. However, a structural evaluation will be necessary before equipment or vehicles can use the facility.

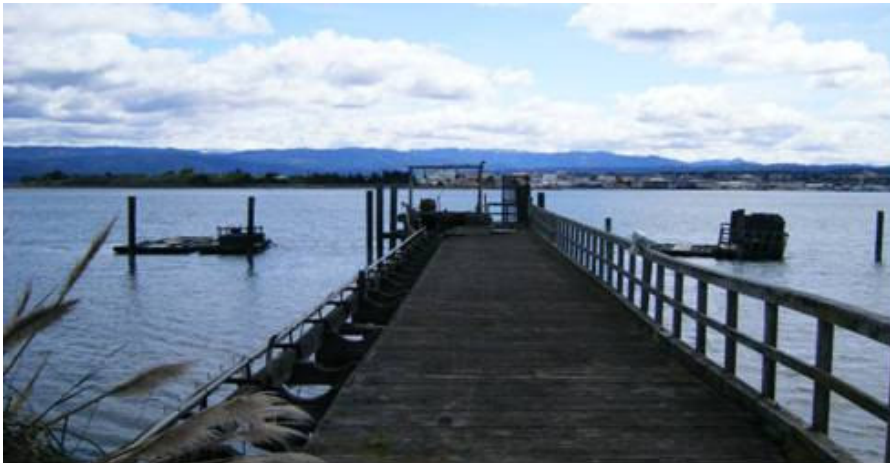
Figure 2-26: Pre-Existing Cogeneration Plant Water Intake Berth

The berth was used to take in water to the pre-existing pulp mill. TranSystems views this berth as having no value for cargo handling operations. Several companies have expressed interest in using the berth for aquaculture activities.

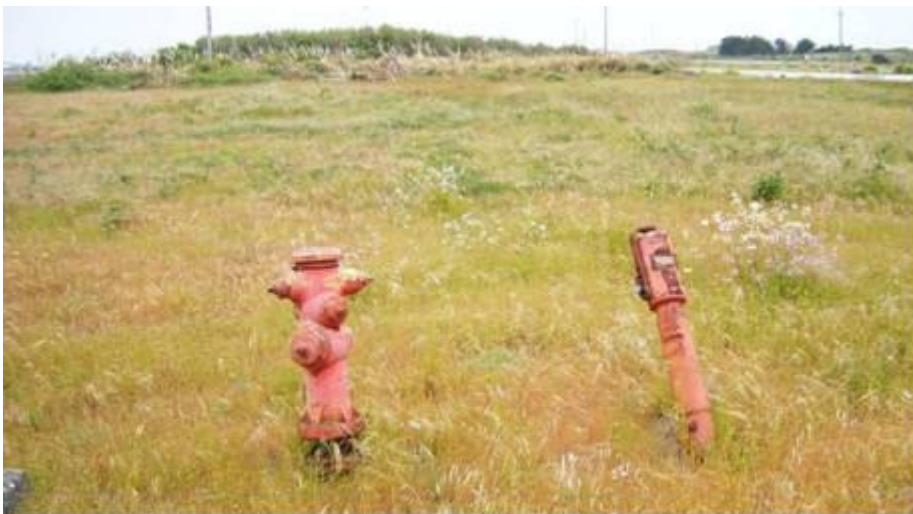
Figure 2-29: Open Storage Vegetated Areas and Fire Protection Utilities

The Redwood Marine Terminal open storage includes about 17 acres of mixed paved and unpaved areas. The surface of the unpaved areas is currently overgrown with low vegetation and the original surface conditions, (gravel, earth, etc.) have not been evaluated. The paved surfaces are relatively clear and appear to be in good condition. This pavement is fully contiguous with paved portions of the adjacent Samoa Property and it can be assumed that the existing drainage and underground utilities are common to both. Portions of the pavement closest to the entry gate, Roundhouse, and Berth 1 appear to have the greatest structural integrity. Figure 2.28 illustrates portions of that pavement to the north of Berth 1 and Warehouse 3, facing the terminal entrance.

Some areas of the pavement show minor damage, but there is little evidence of excessive pavement failure or overloading. This paved area was originally used for storage of sawn timber and heavy truck circulation. Although the design pavement load is unknown, it may be suitable for commercial port use without significant modifications.
